Envirotalk

Ministry of Environment, Planning and Infrastructure Strategy

SUMMER 2011
VOLUME 79 No. 2

THE ADEQUACY OF RAINWATER HARVESTING IN BERMUDA

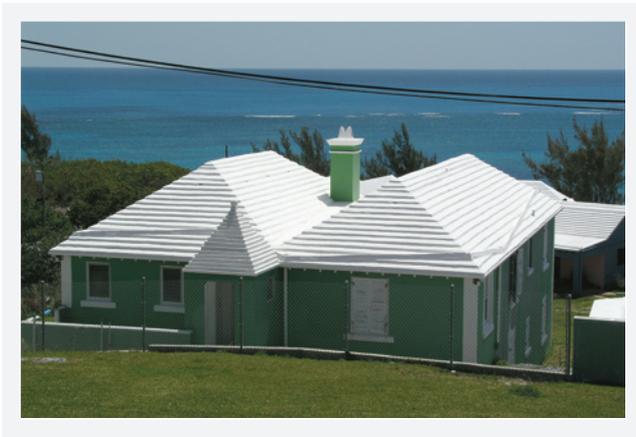
A typical Bermuda roof has a catchment area of 1360 square feet.

Not all rain which falls within the guttered area of a Bermuda roof is transferred to the storage tank. The term 'tank rain' was coined to distinguish rain which greatly benefits water storage levels from that which does not. Studies show that the amount of rain water that is delivered to a tank relative to the amount that falls on a roof — the 'catchment efficiency' — increases with the length and intensity of the rainfall event.

The ineffectiveness of short showers is in part attributable to roof surface roughness and porosity, which must be saturated before run-off will occur. Evaporation is another loss which will reduce run-off and delay its onset, particularly in the summer months. Finally, there is wind, which at

exposed locations has the potential to significantly diminish catchment efficiency. The average long-term efficiency of a Bermuda roof (compared to a standard 4-inch rain gauge) has been measured at 87%.

Based on a long-term average annual rainfall of 57.7 inches, the supply of rainwater harvested from the roof of the 'typical' Bermuda house (defined by Rowe. M.P, 2010) is calculated at 94 Igal/day or 23.5 Igal per occupant (after correction for catchment efficiency). Whilst prior to the 1970s this rate of supply was well matched to the demand of a 4-person household estimated at 80 Igal/day, the typical 4-person household of today, with a demand of 120 Igal/day, experiences a deficit in rain water supply of 26 Igal/day. This figure is consistent with the findings of a homeowner's survey of water use habits conducted by the Ministry of Public Works. The average quantity of supplementary water purchased by those respondents who rely on trucked water was 8.6 truck loads per year (at 900 Igal per load).

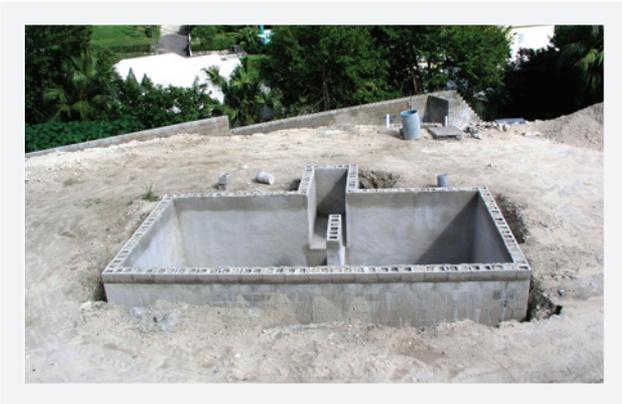
*A typical Bermuda tank has a capacity of 13,500 Imperial gallons.
Photo courtesy of Mark Rowe*

Tank capacity is another factor which has been investigated in recent studies. Contrary to the apparent belief of some builders, a large tank does not substitute for a deficit in the supply of harvested rainfall, caused by insufficient catchment area relative to occupancy/water demand. In fact, only under 'balanced' conditions, when the quantity of harvested rain water is approximately equal to demand, is the maximum regulation tank capacity beneficial. Many residences in Bermuda have unexploited tank capacity, some are always overflowing and others are always depleted. It is recommended that for new high density housing, the regulations be modified such that construction of costly over-sized tanks, which are destined to remain permanently depleted, can be substituted with installation of a well for flushing water.
